# U.S ENVIRONMENTAL PROTECTION AGENCY SUBAREA II FOURTH AVENUE AND GAMBELL STREET REMOVAL ACTION INDOOR AIR QUALITY QUESTIONNAIRE AND BUILDING INVENTORY

Preparer's Name: Robert Whittier/Carl Overpeck Date Prepared: 22-February-2014

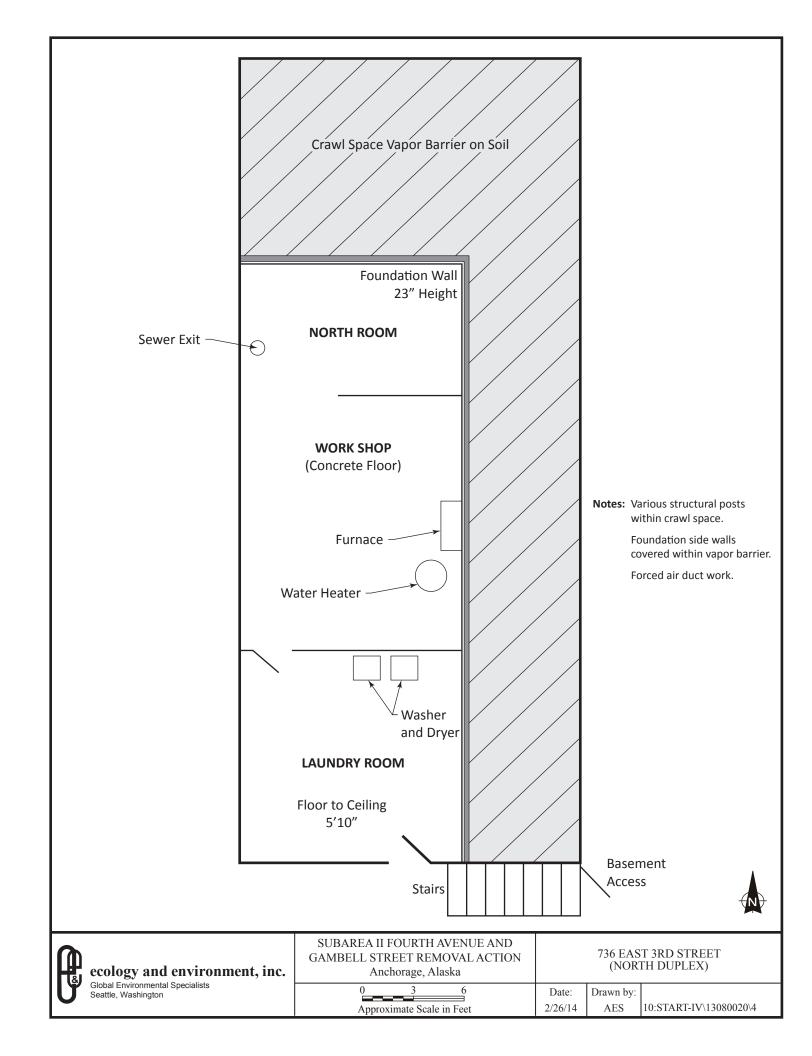
2. General Condition: [ ] Good [ ] Fair [ ] Poor
3. Other Comments: Pre 1981 construction.
10. BASEMENT FLOOR PLANS See attached figure.
11. TEMPORARY STORAGE
Is temporary storage required during performance of the removal action? [X] Y [ ] N
If yes, describe:Utilities, washer & dryer, personal property and work shop. See photos.

If yes, describe: \_Crawl space, electrical wiring, and personal property storage.
